LightTPD Has Been Deprecated at C•CURE 9000 Version 3.00

C•CURE 9000 TAB

Article ID: SWH-TAB-nID-000035061

Published: Jul-14-2022

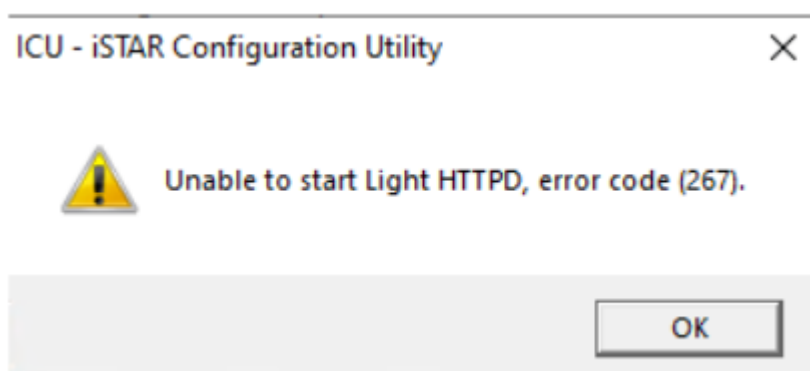
Note: After deleting LightTPD, every time ICU is launched, the system will show the following error (clicking **OK** will resume ICU):
