C•CURE 9000 Technical Assistance Bulletin

TAB number: SWH-TAB-000035806

Topic: iSTAR Ultra G2 ACM Fire Alarm Interlock (FAI) relay drive logic change

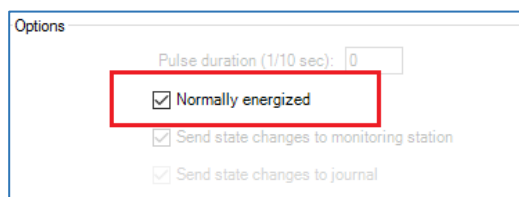
Figure 1: Normally energized checkbox

Software House updated the Fire Alarm Interlock (FAI) relay drive logic on iSTAR Ultra G2 ACMs to align with industry standards.

The FAI relay drive logic operates differently from previous iSTAR Ultra G1 ACMs.

iSTAR Ultra G2 FAI behavior: FAI-enabled relays deactivate and are disabled if FAI activation occurs when the F (fire) input of J84 opens (J84 is NC – normally closed).

iSTAR Ultra G1 FAI behavior: FAI-enabled relays activate if FAI activation occurs.

- **C•CURE:** In the iSTAR Output Editor in C•CURE, outputs must be set to Normally Energized for any FAI-enabled relays as shown in Figure 1 below. Refer to the *Configuring iSTAR Controllers* chapter in the *C•CURE Hardware Configuration Guide* for more information.

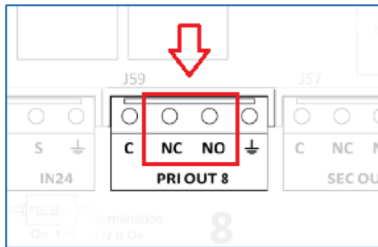
Figure 2: ACM outputs

Note: This is a potential life-safety issue. Failure to reconfigure lock outputs in C•CURE and at the ACM will result in FAI not functioning as expected in an actual fire situation.

- ACM: At the ACM, outputs must be rewired between NO (Normally Open) and NC (Normally Closed) on the relay contact to implement a combination of applying or removing power to release magnetic locks or other door mechanisms.
