C-CURE 9000 Technical Advisory Bulletin

TAB number: SWH-TAB-000037053-B

Topic: iSTAR Ultra G2 V2 ACM and iSTAR Ultra G2 SE V2 ACM board messages cause Application Server performance issues

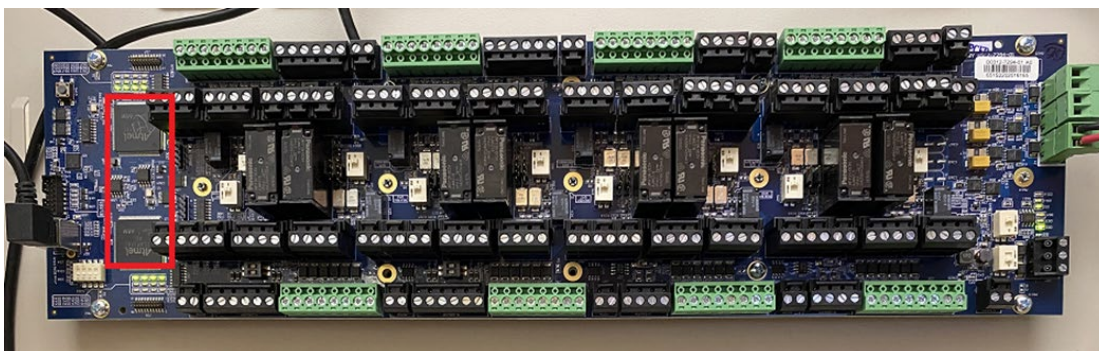
Figure 1 - G2 ACM Full V1

The V2 (version 2) ACM boards used in the iSTAR Ultra G2 and the iSTAR Ultra G2 SE are different to the V1 (version 1) ACM boards. The V1 ACM boards use Atmel microcontroller units (MCU) measuring 0.75 in. x 0.75 in., and the V2 ACM boards use Texas Instruments microcontroller units (MCU) measuring 0.375 in. x 0.375 in. There are two types of V2 ACM boards, Full and SE.
